3. 2(2) 調査計画 (ボアホール)

3.2(3) 調査計画(弾性波探査)

3.2.1 A側線解析結果(暫定)

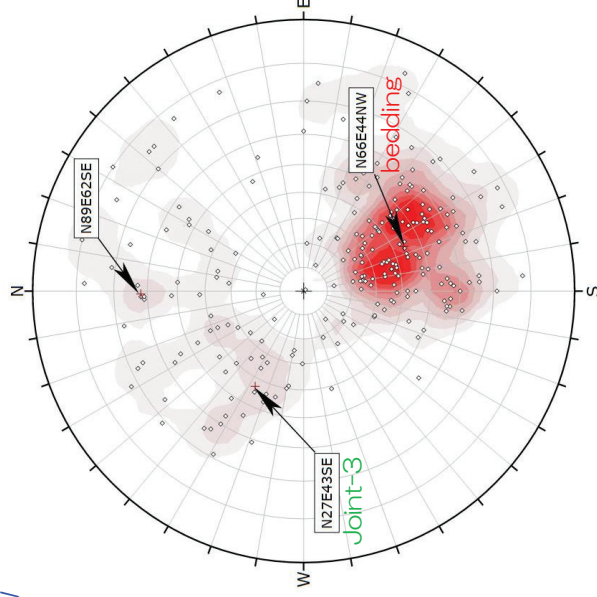
BV-4解析結果(2/6時点暫定解析結果)

Symbol	Feature
○	Pole Vectors
Color	
	Density Concentrations (%)
0.00	0.80
1.60	2.40
3.20	4.00
4.80	5.60
6.40	7.20
8.00	
Contour Data	
Maximum Density	7.70%
Contour Distribution	Fisher
Counting Circle Size	1.0%
Color	
	Dip
1m	44
2m	43
3m	89
4m	62
Mean Set Planes	
	Label
1m	
2m	
3m	
4m	
Plot Mode	
Pole Vectors	
Vector Count	239 (239 Entries)
Hemisphere	Lower
Projection	Equal Angle

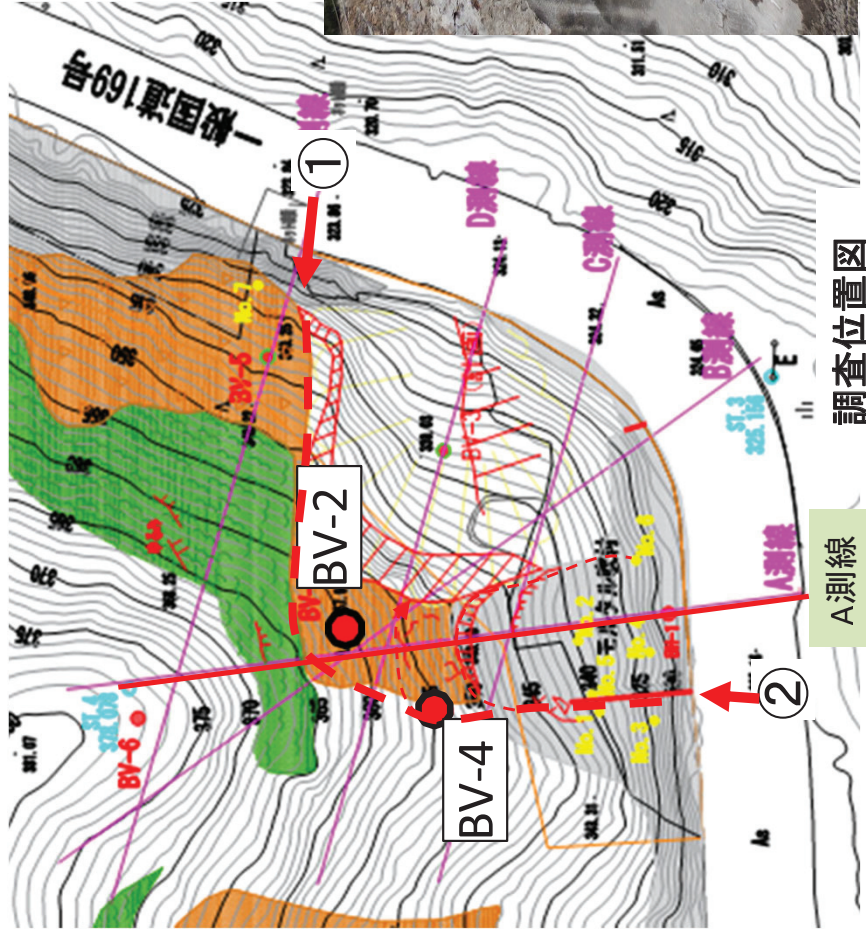
- ・道路終点側で凹状地形を通る測線。
- ・遠赤外線調査では空洞化の懸念が認められた。
- ・調査ボーリングBV-2・4のコア採取・ポアホールカメラの現地調査が完了し今後解析を行う
- ・弾性波探査の結果、P波1000m/s以下の低速度帯が法尻部では層厚約2～3m尾根部では10m程度の暫定結果となる

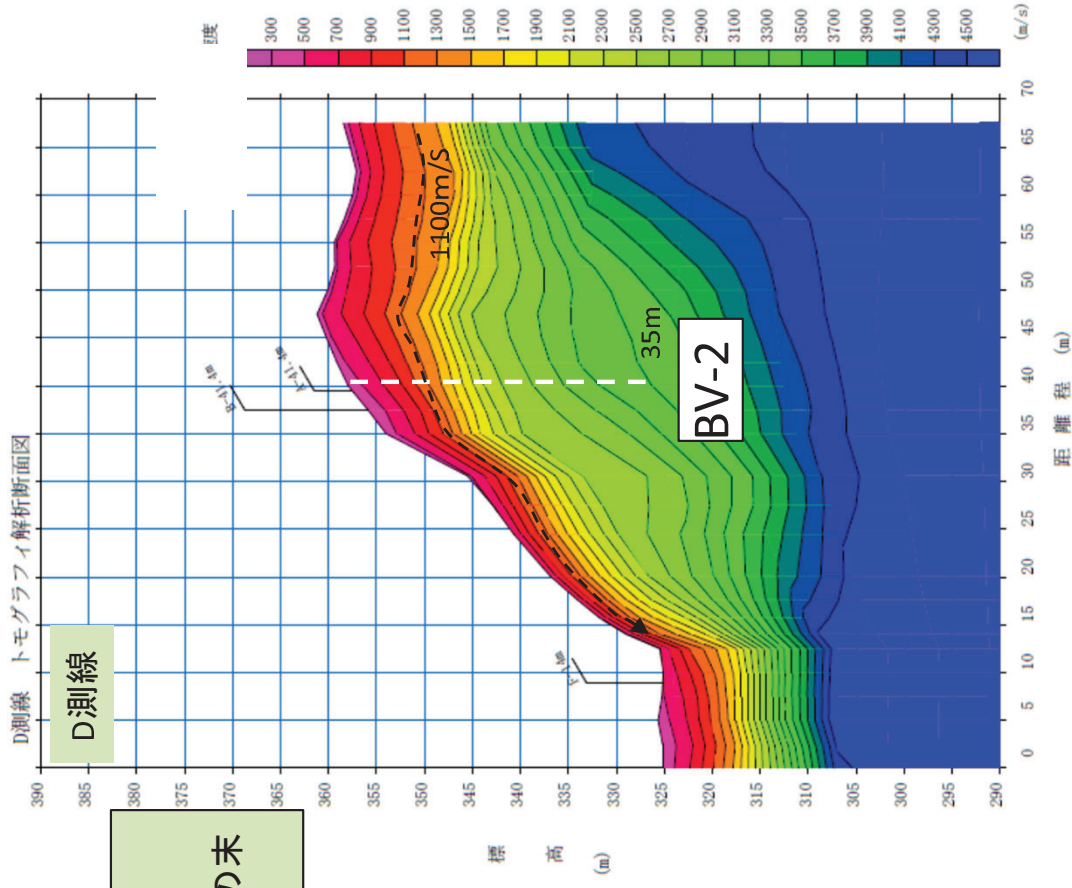
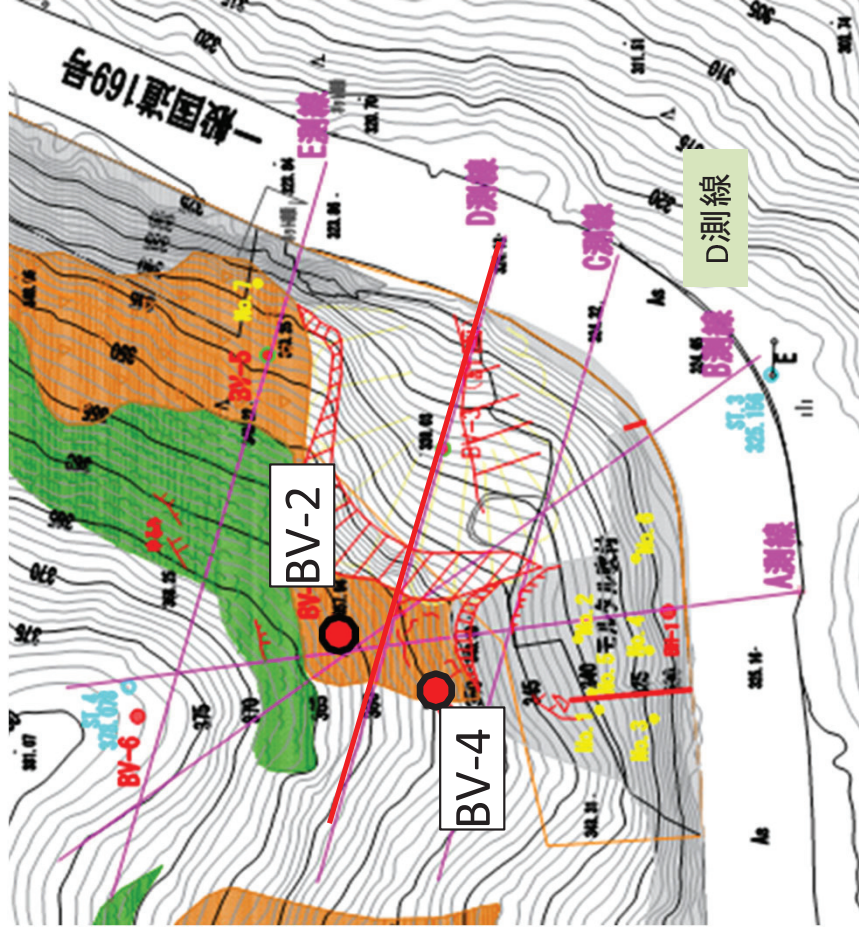
3.2.2 D側線解析結果(暫定)

- ・崩壊地形を通る崩壊後の等高線に直行方向の測線。
- ・調査ボーリングBV-2号孔の現地調査が完了し今後解析を行う
- ・弾性波探査の結果、P波1000m/S以下の低速帯が崩壊地形内の末端では層厚約2～3m頭部付近では5m程度の暫定結果となる
