# Important Cultural Property Horyu-ji To-in Raido

## Guided Tour at Conservation Site

The Raido (Worship Hall) stands at the centre of the south side of the Horyu-ji To-in Corridor. We have been replacing the tile roofs since April 2019. This is the first repair in 84 years, since the previous one in 1935. We have completed the repairs to the roof base and would like to show the public the current status of the hall.

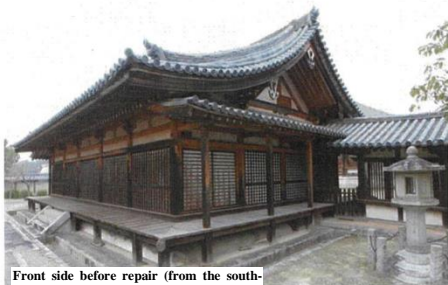
Front side before repair (from the south-east)

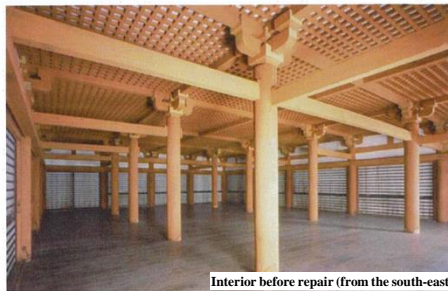
Interior before repair (from the south-east)

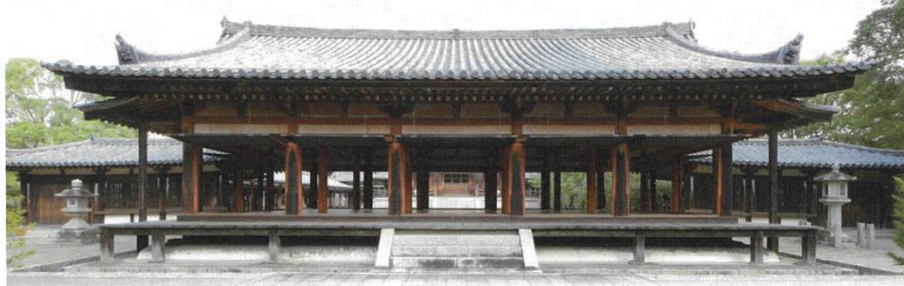
Facade before repair (from the south)

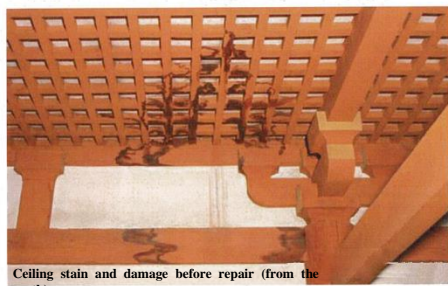
Ceiling stain and damage before repair (from the south)

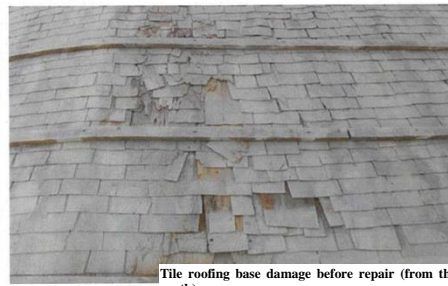
Tile roofing base damage before repair (from the north)

- Removal of damaged parts
- Repair of the removed parts

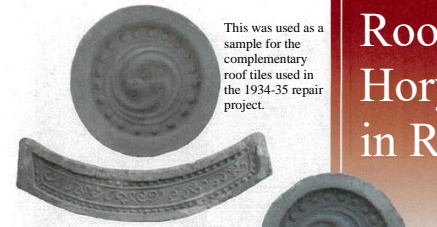
▲(Top) Semi-cylindrical eaves-end pendant tile, 14-15th century  
(Bottom) Broad, concave, eaves-end pendant tile, 12-13th centuries

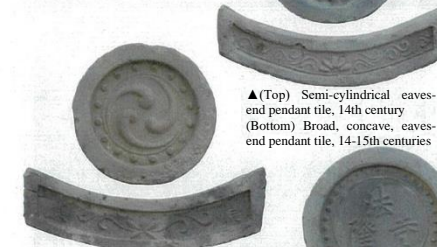
▲(Top) Semi-cylindrical eaves-end pendant tile, 14th century  
(Bottom) Broad, concave, eaves-end pendant tile, 14-15th centuries

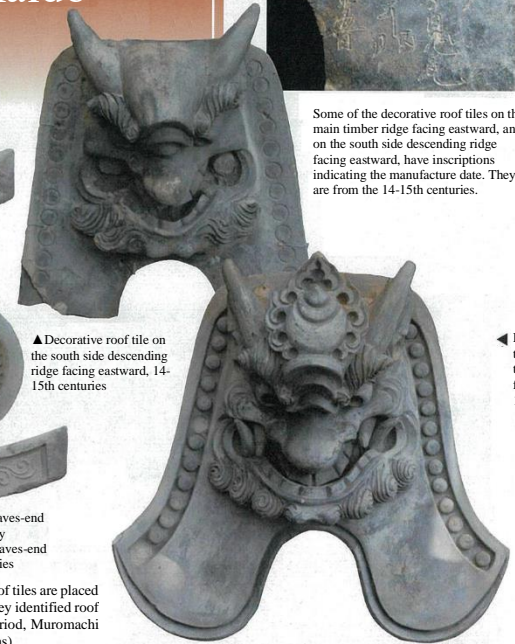
◀Decorative roof tile on the main timber ridge facing eastward, 14-15th centuries

Some of the decorative roof tiles on the main timber ridge facing eastward, and on the south side descending ridge facing eastward, have inscriptions indicating the manufacture date. They are from the 14-15th centuries.
